Assessment of 2016 Mantam Landslide at Mangan, North Sikkim Himalayas using Geospatial Techniques

Abstract: North Sikkim Road Corridor in Sikkim Himalayas is characterized by fine-grained, less permeable earth material and is thus vulnerable to landslides. Mantam is one of the new and active massive rock-cum-debris slides, initiated during the rainy season of 2016. In the Himalayan foot-hills, rainfall precipitation is a major triggering factor for the incidence of landslides. There is no previous study of the rain-induced landslide in the region with geospatial analysis of landslide data and application of rainfall threshold model. In the present study, the causative factors of the Mantam landslide is derived from the analysis of Very High-Resolution satellite images (Cartosat-2B) and High-Resolution LANDSAT 8 (30m) retrieved from National Remote Sensing Center and USGS. This paper presents geological, and geo-hydrological analysis of the Mantam landslide using High-Resolution satellite images and a rainfall threshold is suggested for the prognosticate sliding. This present study suggests a threshold value of ≥ 284.1 mm of cumulative rainfall over a 10 days period for the Mantam

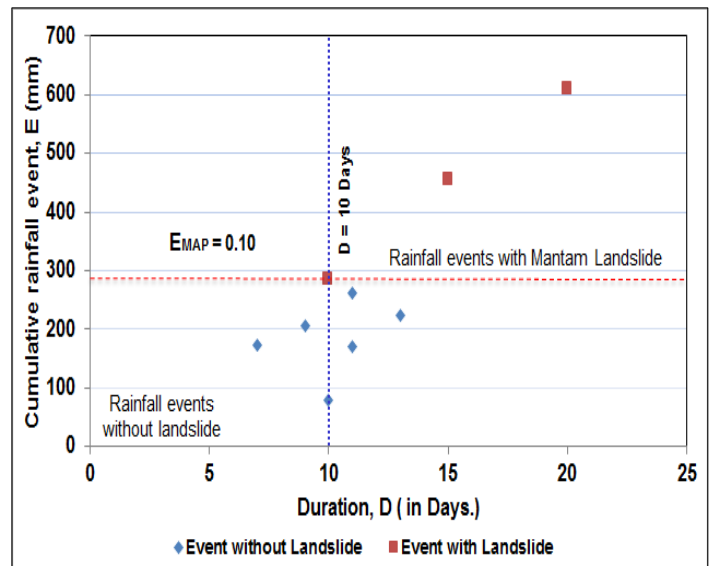
Fig. 11. Rainfall Thresholds based on the plots of total cumulative rainfall (E) against event duration (D) for the newly activated Mantam Landslide. Blue dots area represents not associated with sliding and Red dots predict a high probability of Mantam landslides. The E value of 284.1 mm and D of 10 days, while slide-associated events (in red) occur at higher values.

Fig. 8 represents the monthly rainfall data at Mantam. Yearly average rainfall has been calculated from historical rainfall records of this rainfall station. The cumulative rainfall (E, in mm) and the duration of rainfall (D, in days) are plotted for all the peak rainfall events (Fig. 11). A cumulative rainfall event and duration (E&D) have been shown in Table II. Figure 11 shows the thresholds analysis based on the plots of total cumulative rainfall events (E) against the duration of rainfall (D) for the newly active Mantam Landslide. Table II and Fig. 11 shows that the relation of rainfall events that induced landslide at Mantam requires ≥ 284.1 mm cumulative rainfalls within a 10 days period. If this threshold value E is normalized, the E_{MAP} value exceeds 0.10 which indicates high probability of landslides. So, the landslide may occur at Mantam, if E_{MAP} is ≥ 0.10 for any rain event of 10 days or more (as shown in Fig. 11). Based on this observation as simple exponential relation, between occurrence of landslide and duration of rainfall was plotted. The events of rainfall not associated with landslide are represented in blue dots. The red dots show events associated with cumulative rainfall (E value of 284.1 mm (or E_{MAP} of 0.10), and D of 10 days.). This threshold value is very similar to one proposed by Sengupta et al. (2009), at Lonta Khola Slide in the Sikkim Himalayas. When the rainfall event has an E value of 455.3 for 15 days (E_{MAP} value is 0.16) and 609 mm for 20 days (E_{MAP} value is 0.18) duration they represent a high probability of landslides. Thus it can be said that landslide occurs when E_{MAP} value exceeds 0.10 (10 days). Table II represents the data of events in hours and days with maximum intensity of rainfall during the event. Cumulative rainfall during an event and normalized (E_{MAP}) cumulative rainfall for all the rainfall events are thus examined in this study. Considering all observations and estimations it shows that a total of 284.1 mm of cumulative rainfall over at least 10 days is responsible for the occurrence of Mantam landslide.

Analysis of the rainfall and landslide data of the Mantam landslide in North Sikkim Himalayas puts forward a local threshold model estimation based on the E (or E_{MAP}) value. The exponential relation of the model found that the Mantam landslide was induced when E value exceeds 284.1 (E_{MAP} value is ≥ 0.10) over 10 days of cumulative rainfall. The threshold relation also shows that when E_{MAP} value lies between 0.05 and 0.10 over the 10 days period, then there is a moderate probability of landslides and if E_{MAP} value is < 0.05 over the same time period, it is considered as safe. The threshold values have been calculated based on limited available data. Finally, the study suggests that the threshold value is greater than or equal to 284.1 mm of cumulative rainfall over the 10 days period for the Mantam landslide initiation. Thus the threshold displacement for the landslide is E_{MAP} value of ≥ 0.10 .
